**Title:       Stage 1 Road Safety Audit and Quality Audit,  
For;  
Proposed Residential Development at, Grace Park Court,  
Beaumont Road, Dublin 9.**

**Client:       Waterman Moylan Consulting Engineers on behalf of Urban  
Life.**

**Report reference: 2966R02**

## St 1 RSA & QA – Beaumont Road

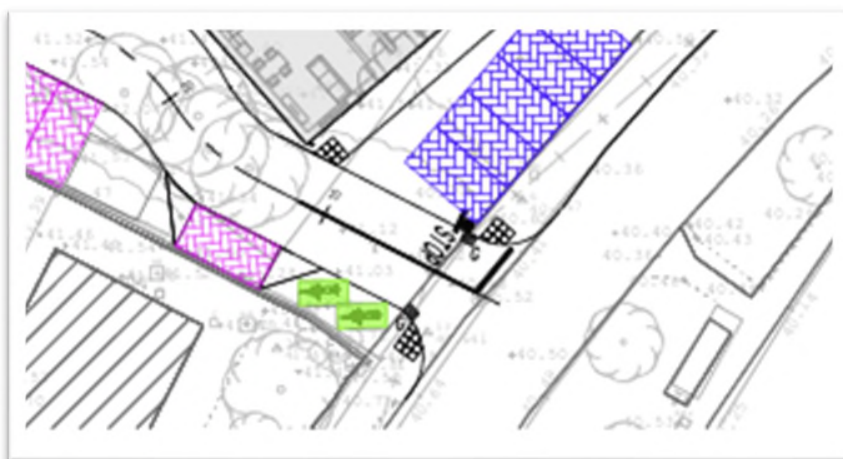
Drawing PRD-WMC-ZZ-XX-DR-C-P2020, Rev - , Southern access.

There is no pedestrian route at the southern access. Pedestrians will have to share space with vehicles which could lead to collisions.

It is recommended that a footpath be provided or that the street be changed to a shared use street with all the features expected of one including a pedestrian refuge area.

| Paragraph No.<br>in Safety Audit<br>Report | Issue<br>accepted<br>(yes/no) | Recommended<br>measure<br>accepted<br>(yes/no) | Alternative measures (describe) | Alternative<br>measures<br>accepted by<br>Auditors<br>(Yes/No) |
|---|---|---|---|---|
| 4.1 | Yes | Yes | | |

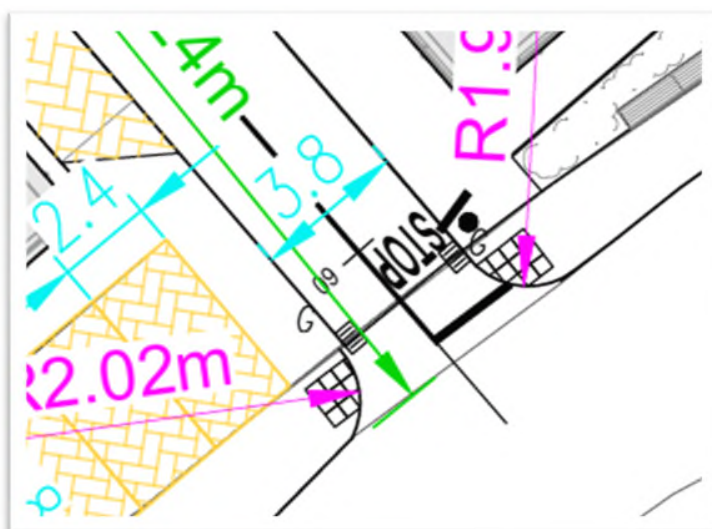
Drawing PRD-WMC-ZZ-XX-DR-C-P2030, Rev - , Northern access.

The carriageway width at the mount of the junction is proposed to be 3.8m. This is too narrow for two vehicles to pass and will lead to side-swipe collisions. A delay in getting vehicles into the car park could lead to queuing onto Beaumont Road resulting in rear-end collisions.

It is recommended that a suitable carriageway width be provided to allow vehicles to pass.

| Paragraph No.<br>in Safety Audit<br>Report | Issue<br>accepted<br>(yes/no) | Recommended<br>measure<br>accepted<br>(yes/no) | Alternative measures (describe) | Alternative<br>measures<br>accepted by<br>Auditors<br>(Yes/No) |
|---|---|---|---|---|
| 4.2 | Yes | Yes | | |

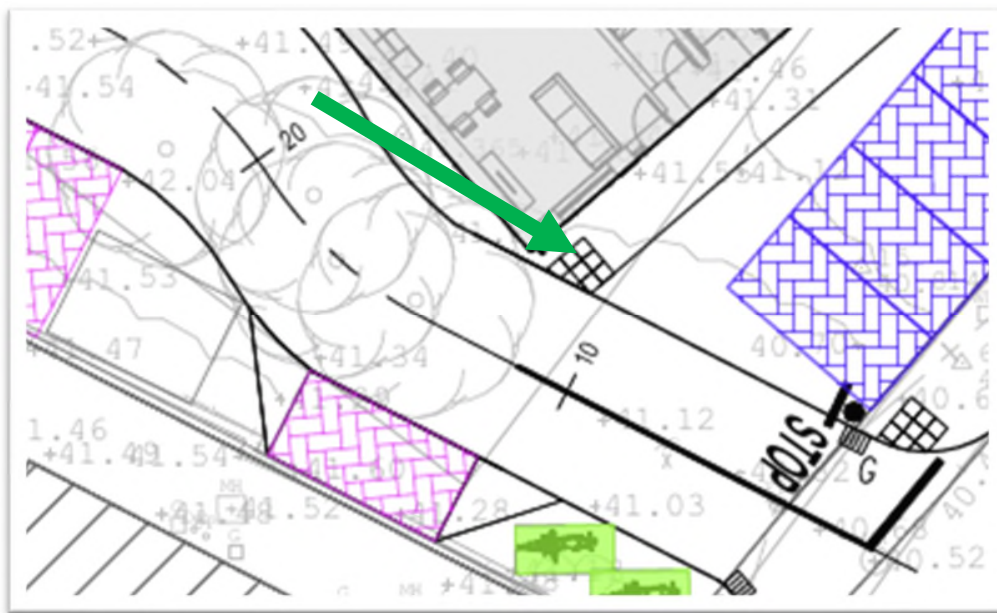
Drawing PRD-WMC-ZZ-XX-DR-C-P2020, Rev - Internal footpath southern block.

There will be limited inter-visibility between exiting drivers and pedestrians entering the carriageway at the front of the southern block. This could lead to collisions.

It is recommended that adequate inter-visibility be provided.

| Paragraph No.<br>in Safety Audit<br>Report | Issue<br>accepted<br>(yes/no) | Recommended<br>measure<br>accepted<br>(yes/no) | Alternative measures (describe) | Alternative<br>measures<br>accepted by<br>Auditors<br>(Yes/No) |
|---|---|---|---|---|
| 4.3 | Yes | Yes | | |

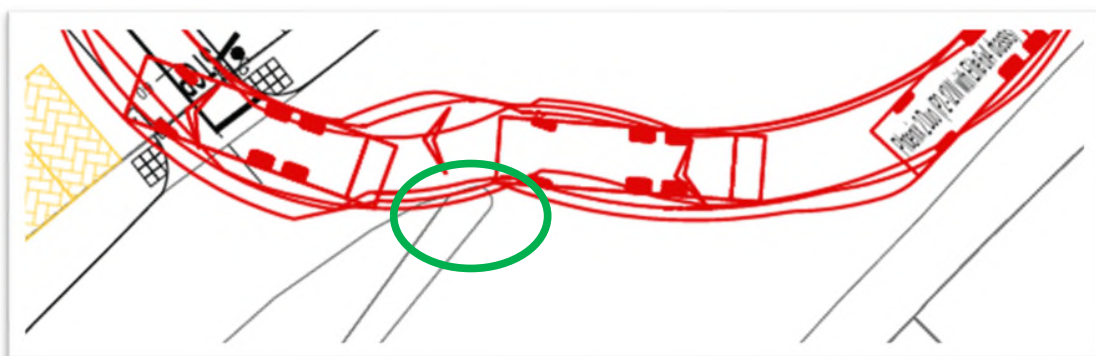
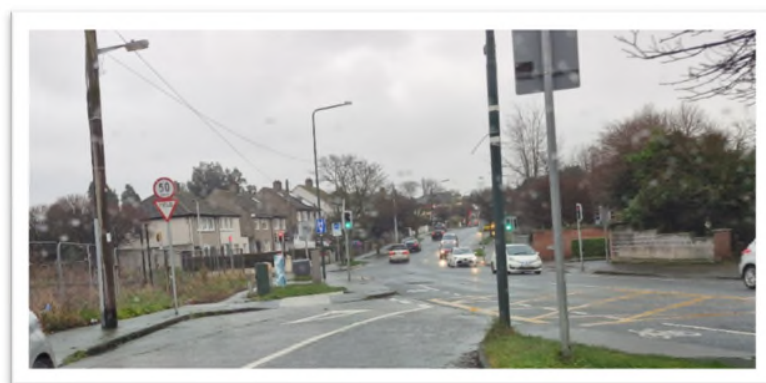
Drawing PRD-WMC-ZZ-XX-DR-C-P2052, Rev -, Swept path for refuse vehicle.

The swept path shows that a refuse vehicle may strike the utility pole at the access to Grace Park Court Loop from Beaumont Road. This could lead to material damage of the utility pole.

It is recommended that the layout be modified to ensure there is a clear gap between the utility pole and the overhang of the swept path.

| Paragraph No.<br>in Safety Audit<br>Report | Issue<br>accepted<br>(yes/no) | Recommended<br>measure<br>accepted<br>(yes/no) | Alternative measures (describe) | Alternative<br>measures<br>accepted by<br>Auditors<br>(Yes/No) |
|---|---|---|---|---|
| 4.4 | Yes | Yes | | |

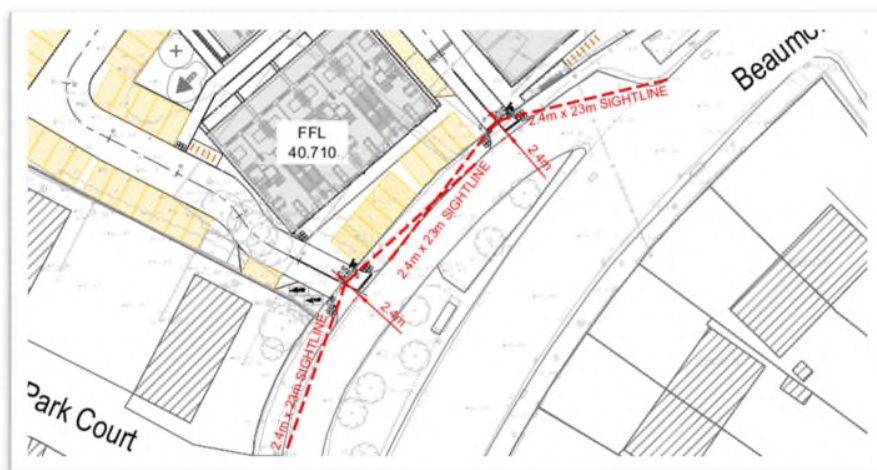
Drawing PRD-WMC-ZZ-XX-DR-C-P2016, Sightlines.

It was observed that parking takes place along the loop road. If this practice continues this could lead to the blocking of sightlines and side-impact or rear-end collisions.

It is recommended that a double yellow line be provided along the extent of the sightlines after the pavement works are complete.

| Paragraph No.<br>in Safety Audit<br>Report | Issue<br>accepted<br>(yes/no) | Recommended<br>measure<br>accepted<br>(yes/no) | Alternative measures (describe) | Alternative<br>measures<br>accepted by<br>Auditors<br>(Yes/No) |
|---|---|---|---|---|
| 4.5 | Yes | Yes | | |

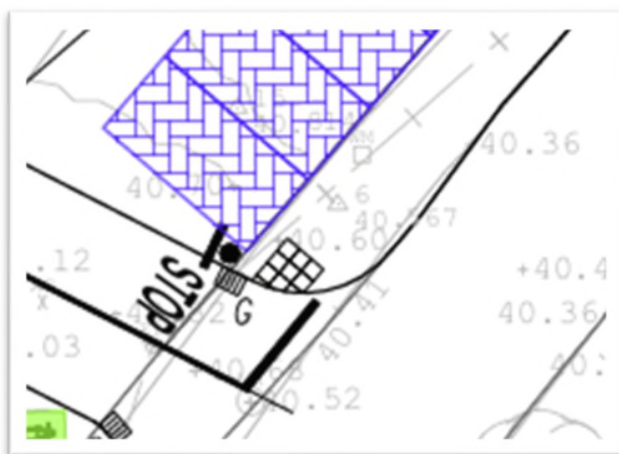
PRD-WMC-ZZ-XX-DR-C-P2020, perpendicular parking space.

Access to the last perpendicular parking space will be across the tactile paving and very close to the stop sign. This will be a hazard for pedestrians crossing the access.

| Paragraph No. in Quality Audit Report | Problem accepted (yes/no) | Recommended measure accepted (yes/no) | Alternative measures (describe) | Alternative measures accepted by Auditors (Yes/No) |
|---|---|---|---|---|
| 5.1 | yes | | | |

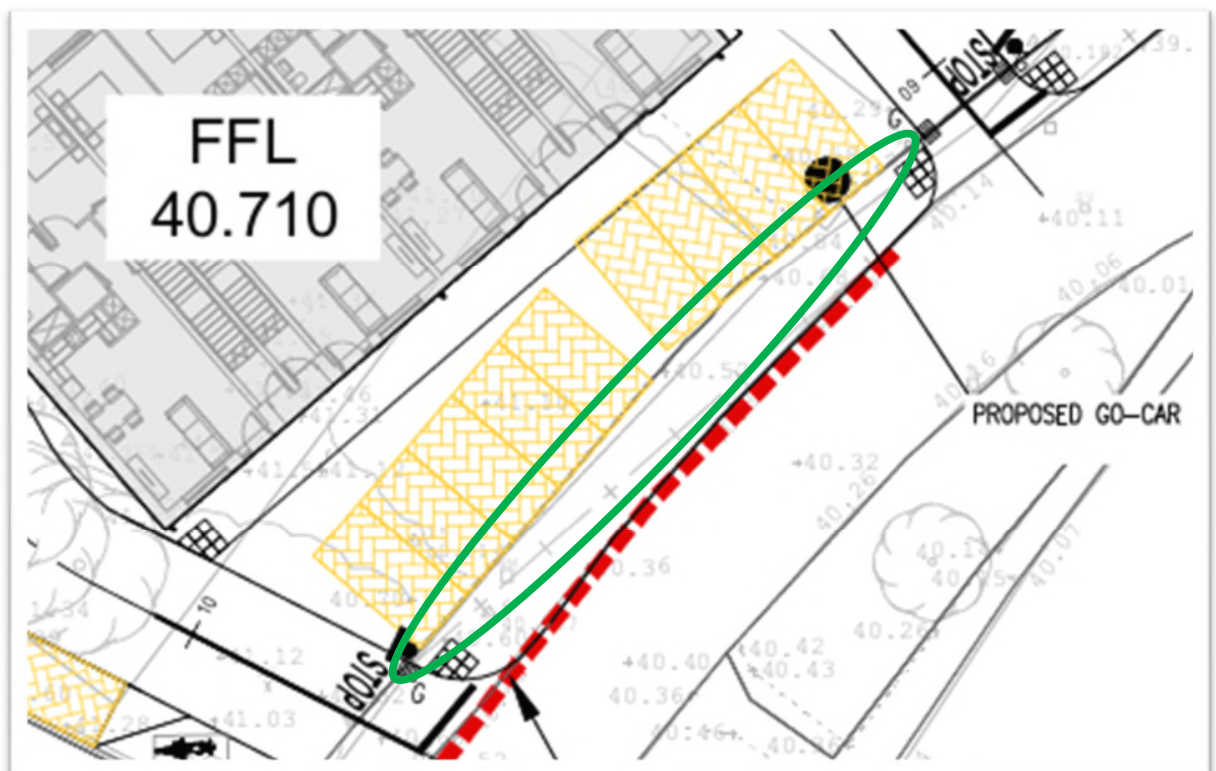
PRD-WMC-ZZ-XX-DR-C-P2020, perpendicular parking spaces.

It is unclear what height of kerb upstand is proposed at the perpendicular parking along the loop road. The existing kerb is full height and may lead to bounce back of wheels. Too low of a kerb may not be detected by visually impaired pedestrians and they may inadvertently stray into the carriageway.

It is recommended that a suitable height kerb be provided for vehicle access.

| Paragraph No. in Quality Audit Report | Problem accepted (yes/no) | Recommended measure accepted (yes/no) | Alternative measures (describe) | Alternative measures accepted by Auditors (Yes/No) |
|---|---|---|---|---|
| 5.2 | yes | | | |

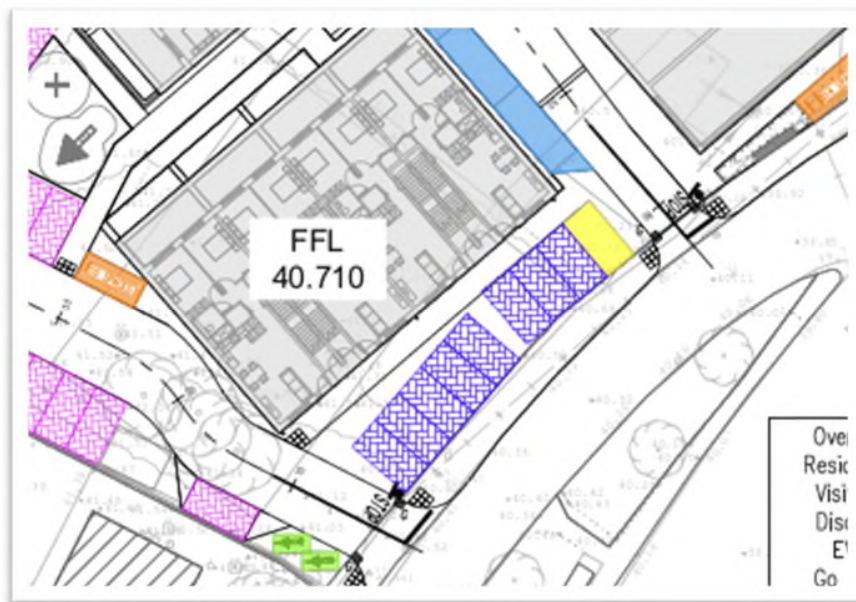
Drawing PRD-WMC-ZZ-XX-DR-C-P2020, Rev - , two accesses.

There are two accesses proposed within a short distance and they will have relatively low traffic movements in and out due to the small amount of car parking. Pedestrians on the footpath however have to give way to traffic twice and higher priority is given to vehicular traffic in this quiet loop road.

It is recommended that continuous footpaths be provided at the access points as per the details provided in Advice Note 6 of DMURS.

| Paragraph No. in Quality Audit Report | Problem accepted (yes/no) | Recommended measure accepted (yes/no) | Alternative measures (describe) | Alternative measures accepted by Auditors (Yes/No) |
|---|---|---|---|---|
| 6.1 | yes | | | |
